CLEARPATH®

UPDATING CLEARPATH GNSS RECEIVER TO v1.201

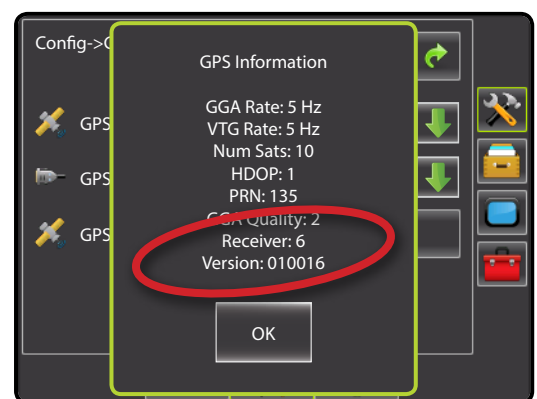
Determine if update is needed

Do not proceed with this update if:

- The "Receiver" is not 6 or 7
- The "Version" is not 010016, 010102 or 010105.

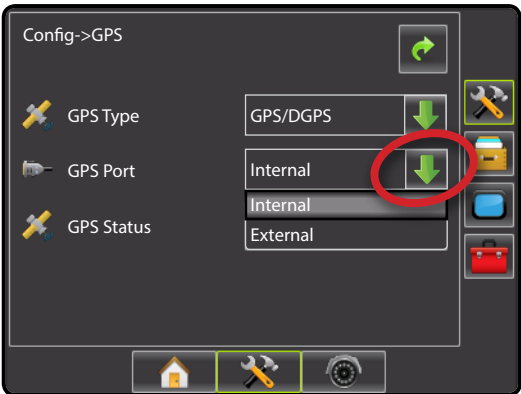
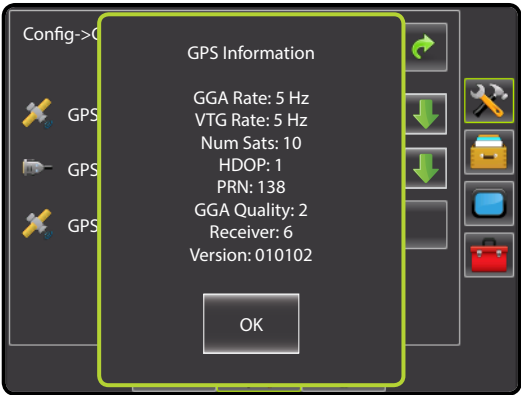
to power on the console again.
12. Go to Config->GPS->GPS Status Information and verify that “Receiver” shows 6 or 7, and now the “Version” shows **010201**.

If the “Receiver” is 1 and “Version” is blank, the update did not complete. Repeat steps 6-12.
